CHAPTER 4

THE JULY 16, 1990 LUZON EARTHQUAKE

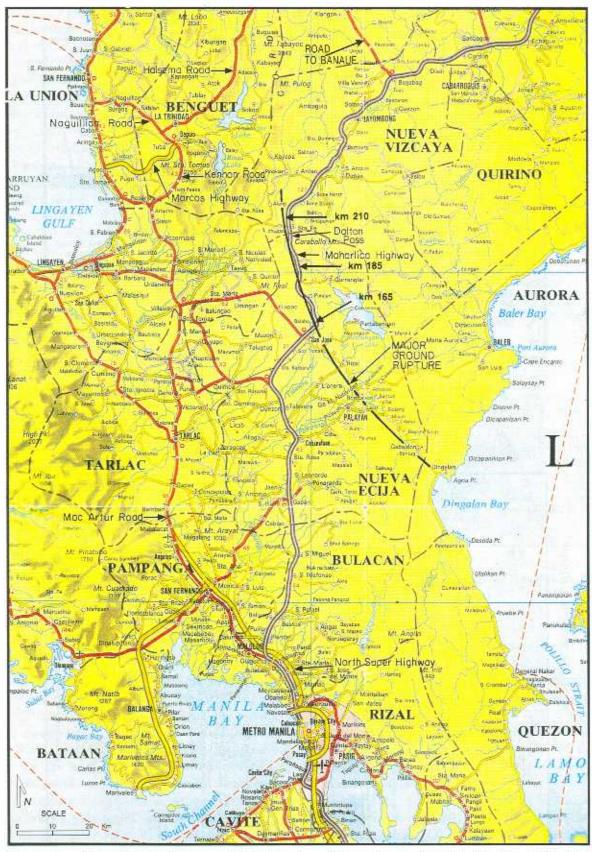
Fig. 4.11 - Map of Central Luzon with the location of the major roads affected by the quake. The section between San Jose' and Santa Fe', km 165 to km 205, of the Dalton Pass Road (Maharlika Highway) crosses the Major Ground Rupture several times (Figures 4.13 through 4.15).

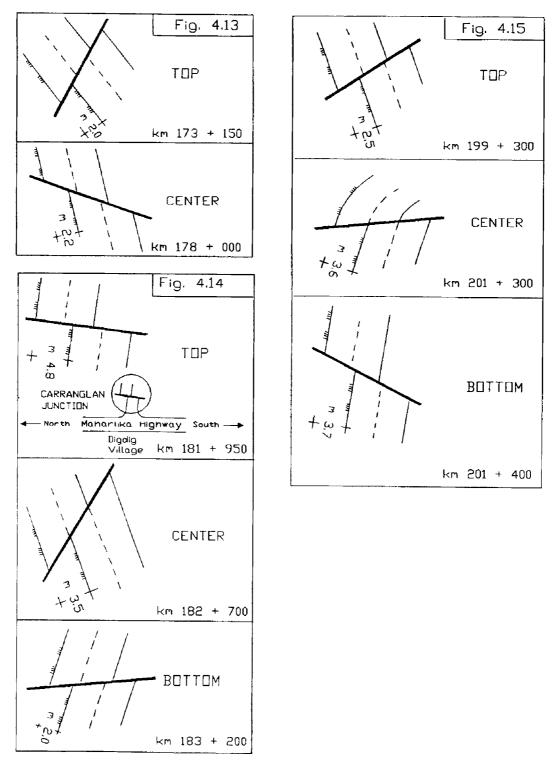
Fig. 4.12 – Geometric sketches of the broken rigid pavement shown in Figures 4.13 through 4.15, due to the ground rupture (Dalton Pass road). The apparent horizontal slip is related to the margin of the cement concrete slabs.

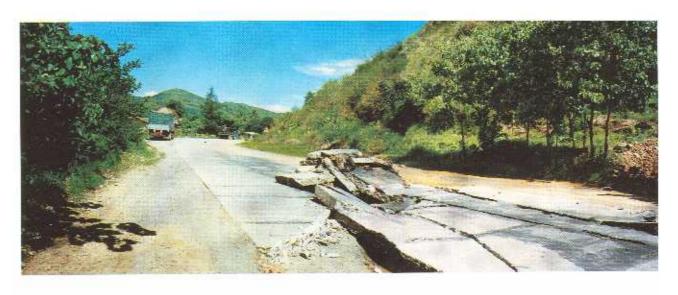
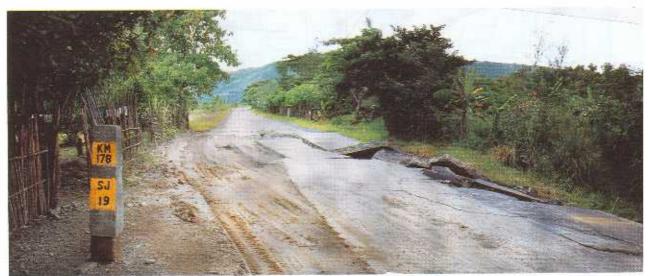
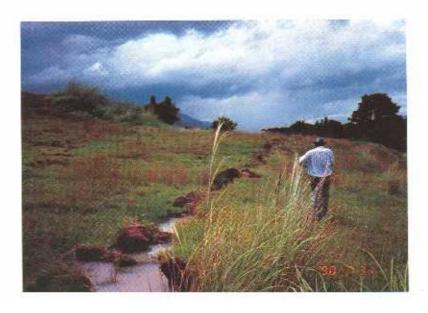
Fig. 413 - Ground ruptures damaging the Dalton Pass road at km 173+150 (top), km 178+000 (center) and near km 180 (bottom). Courtesy of DPWH and Katahira.

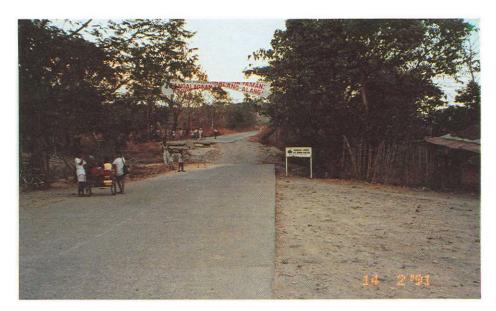
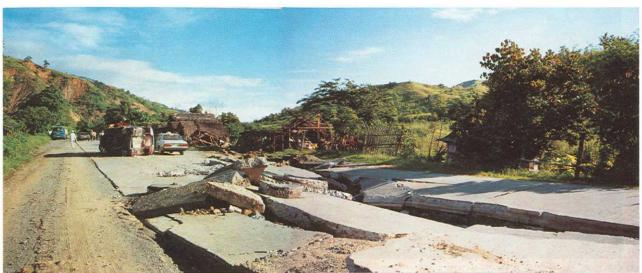
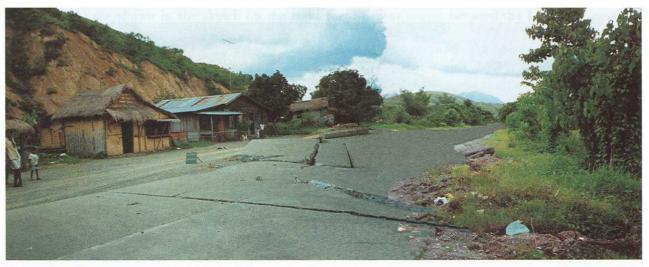
Fig. 4.14 – Faulting in Digdig, at the junction for Carranglan village (km 181+950 of the Maharlika Highway), with 4.8 m horizontal and 1.5 m vertical displacements (top). Fault crossing the road at km 182+700 (center) and at km 183+200 (bottom). Courtesy of DPWH and Katahira.
