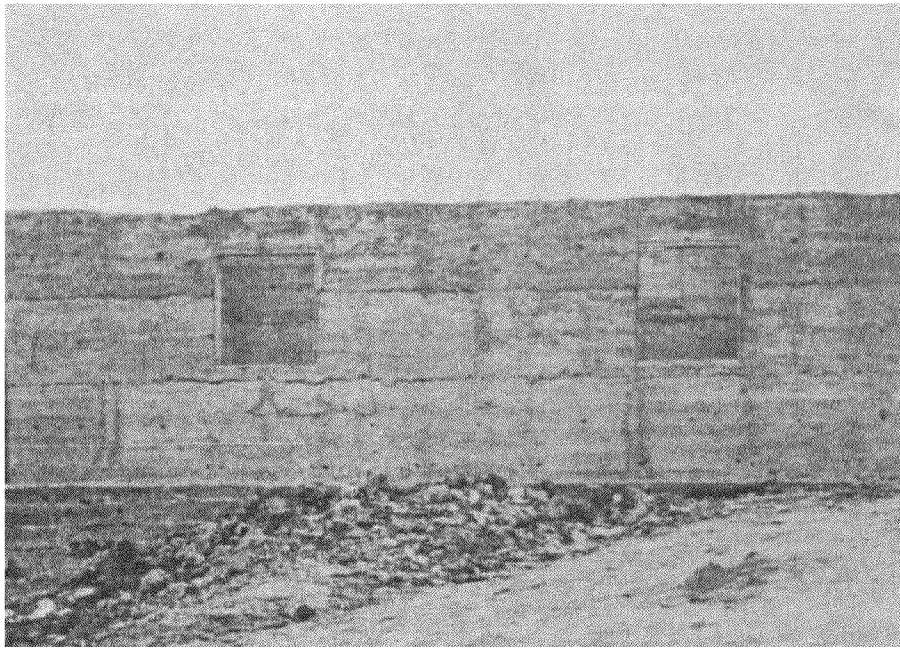
View of a whole wall tamped in three layers
This wall has not yet been finished or water
proofed. On top the rears that fix the wood
tie beam to the earth wall can be seen.

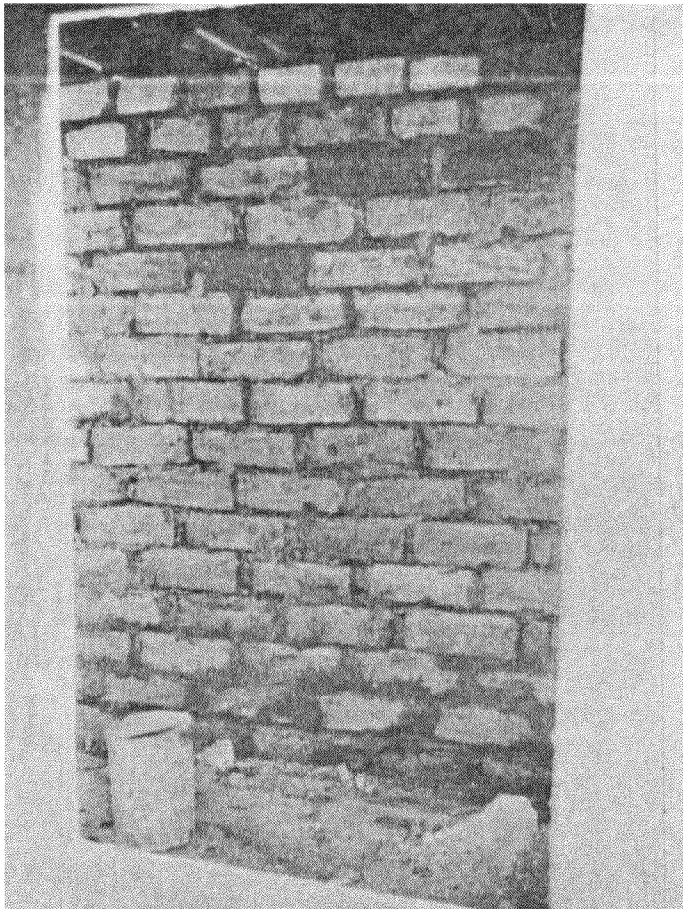
A view of an interior adobe
wall shot through a window.
This wall does not yet have
a finish on it.
