CHAPTER 4

THE JULY 16, 1990 LUZON EARTHQUAKE

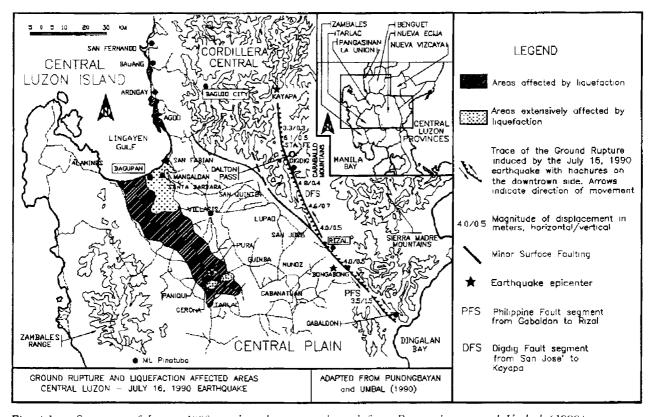
On July 16, 1990 a catastrophic earthquake of 7.7 Magnitude with epicenter near Rizal City hit Luzon causing 1,666 casualties and extensive damage (Fig. 4.1). The event was interpreted by PHIVOLCS as a multiple-shock quake with two major epicenters along the Philippine and Digdig Faults. A 120 km-long major ground rupture between Gabaldon in Dingalan Bay and Kayapa (30 km E of Baguio) and two minor rupture zones NW of Rizal City were associated with the ground-shaking. Along the major surface faulting the ground underwent a horizontal left lateral strike-slip motion, with maximum displacement of 6.2 meters, unprecedented this century (Sharp, USGS-PHIVOLCS Report, 1990).

Fig. 4.1 - Overview of Luzon 1990 earthquake area, adapted from Punongbayan and Umbal (1990).

Liquefaction occurred in a 70-km long and 20-km wide strip in Pangasinan and Tarlac provinces (Fig. 4.1). Sand boils, fountains and fissures were reported in the coastal areas of San Fernando in La Union province and in numerous other locations SW and W of the ground rupture in the Central Valley. Dagupan City on the Gulf of Lingayen was catastrophically damaged, while towns and villages in the Central Plain were badly affected.

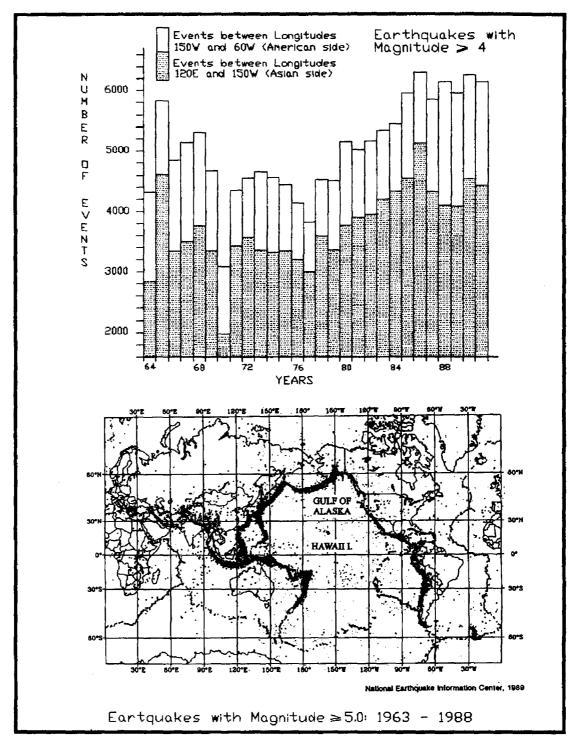
Figure 4.2 (upper sketch) shows the number of earthquakes per year (Magnitudes above 4) from 1964 to 1991 within the region including the Pacific Plate and adjacent smaller plates. In each column the lower part represents events on the Asian side, the upper part events on the American side.

The whole comumns (events within the entire Pacific Region) show a decreasing trend in the period 1965-77, with a minimum of 3,820 quakes in 1977; a sizable increase in seismicity occurs from 1978 onward, with a maximum of 6,290 quakes in 1986 and an average of 6,085 events per year in the period 1985-91.

In general, the seismicity along the coast of the Americas (upper part of the columns) decreases from about 1.500-1,600 to 900 events per year during 1964-1978 (with a minimum of 817 events in 1977); it is nearly stable within the narrow range of 1,124-1,175 quakes from 1979 to 1986, rising to 1,500-2,000 events in the 1987-91 period.

By comparison, the seismicity level along the western margin of the Plate (lower part of the columns) is mainly in the range of 3,200-3,300 events per year during 1964-1979, increases from 3,370 events in 1979 to 4,551 in 1985, and fluctuates in the range 4,090-4,540 events during the 1987-91 period.

Considering the overall seismicity of the Pacific region as broadly derived from the sum of earth-quakes occurring along the western and the eastern boundaries of the plate, the Asian side appears to have been affected by a sizable increase in seismicity, compared to the American side, during 1977-86. The contribution to the western Pacific from the Aleutian Island Arc is not significant since the number of events per year, between 1964 and 1991, has a little variation over that period in the Aleutian Basin.

Fig. 4.2 – The histogram (top) shows the number of carthquakes per year concerning the entire Pacific Region (whole columns), the western part of the Pacific Plate (lower columns) and the eastern part of the Plate (difference in height between the two), during the 1964-1991 period. The number of yearly earthquakes (above Magnitude 4) was derived from the catalogue of the International Seismological Centre (U.K.). The lower sketch (USGS-NEIC) visualizes the Pacific region and the areas to which histogram is related, that is Longitudes 120E - 60W (Lat. 75S-75N) for the entire Pacific Plate, Longitudes 120E - 150W for its western portion and Longitudes 150W · 60W for the eastern part.

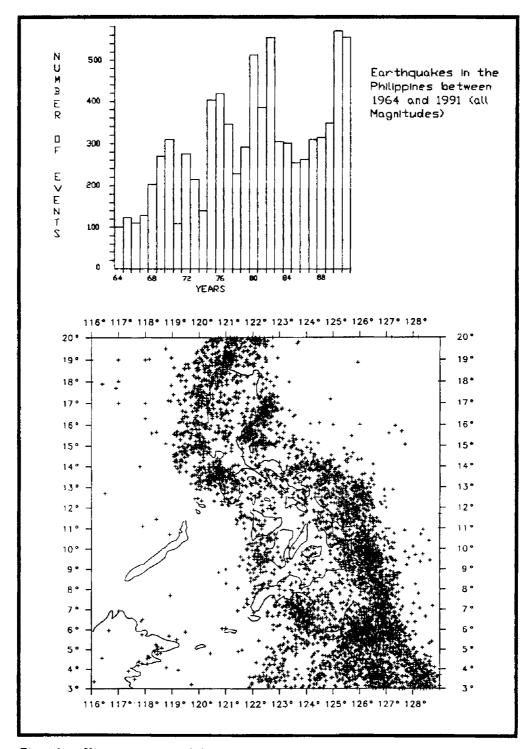
Fig. 4.3 – Histogram (top) of the yearly number of earthquakes in the Philippines (all Magnitudes) during the period 1964-1991 (International Seismlogical Centre, U.K.). The lower sketch (ING), which visualizes the reference area, shows earthquake epicenters in the 1964-1988 period.

Figure 4.3 (upper sketch) illustrates the number of earthquakes per year in the Philippines (all Magnitudes) during the period 1964-1991. The seismicity of the Archipelago shows a marked increase from 1964 onward, with critical periods (and destructive earthquakes) in 1970, 1976, 1982 and 1990-91 (see Table 2.1).

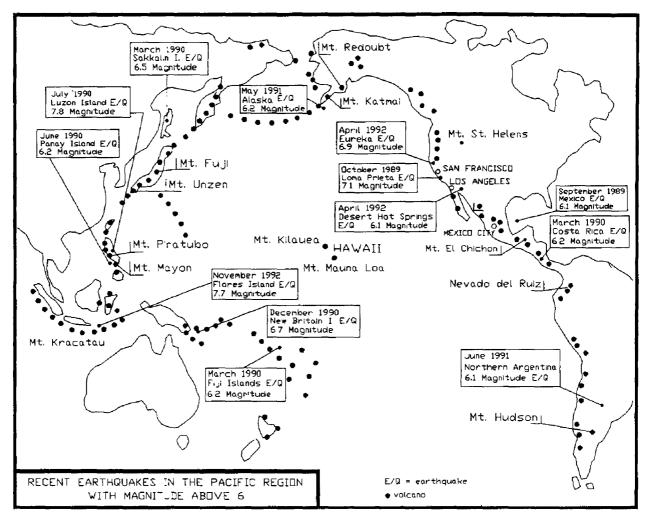
Fig. 4.4 - Strong earthquakes in the Pacific Plate region, 1989-1992.

The location and Magnitude of strong earthquakes in the Pacific during the 1989-1992 period is shown in Figure 4.4. An essential source of information on seismicity in the Philippines is the Catalogue of Philippine Earthquakes, 1589-1899 by William Repetti (1946). This summarizes seismic activity during the period of Spanish occupation. A more recent source is volume IV by SEASEE (1985) which lists all available data up to 1985. The oldest earthquake record concerning the Philippines is dated 1589.

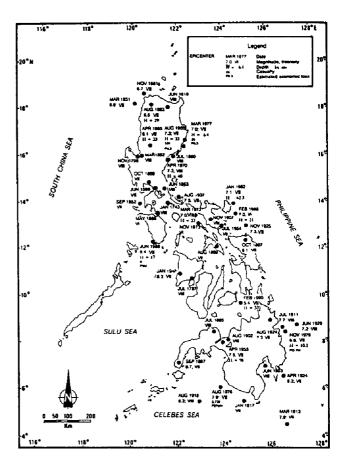
Historical data show that the archipelago was shaken by frequent quakes of various intensities, with many destructive events between 1589 and 1988 (Fig. 4.5). Except for the events during this century, the location of the previous strong quakes is based on damage distribution and other historical information provided by Spanish sources.

Fig. 45 - Distribution of epicenters of major earthquakes (M > 6 and/or Intensity > VI) in the Philippines, 1599-1988 (Earthquake and Tsunami, PHIVOLCS, 1990). Intensity is based on the Rossi-Forel scale (Appendix C).

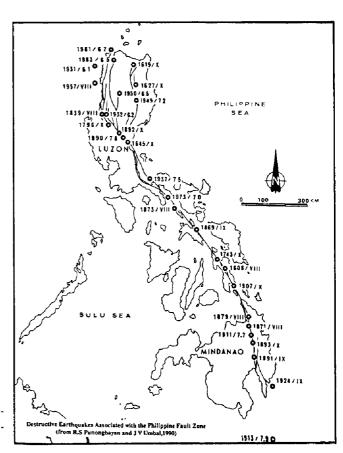
Figure 4.6 shows revised locations of epicenters of the major historical earthquakes along the Philippine Fault zone. Because of differences in the interpretation of data and the consequent location of epicenters, Figures 4.5 and 4.6 are not directly comparable.

Fig 46 - Destructive earthquakes along the Philippine Fault zone during the last four centuries (Punongbayan and Umbal, 1990)

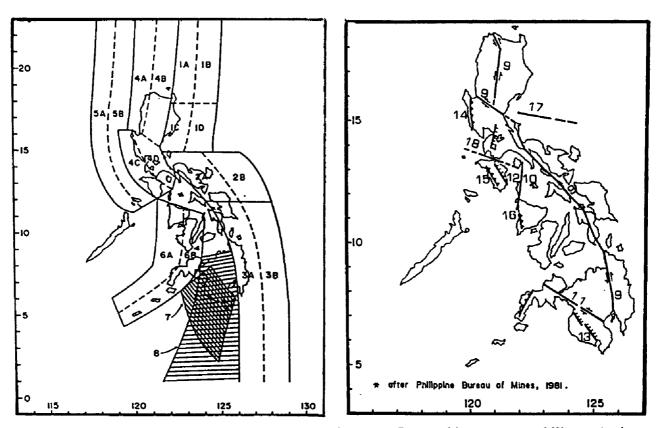
Fig. 4.7 - Earthquake Source Zones 1 to 8 and 9 to 18 (Su, 1988), Reprinted by permission of Kluwer Academic Publishers.

Figure 4.7 shows Source Zones from 1 to 8 (left sketch), which are basically related to focal mechanisms of the thrust and strike-slip types, and to mechanisms associated with Benioff zones and trenches. Figure 4.7 illustrates also the major tectonic lineaments in the Philippines treated as finite-width Source Zones from 9 to 18 (right sketch). These include transcurrent, normal and thrust faults (according to the Philippine Bureau of Mines, 1981).

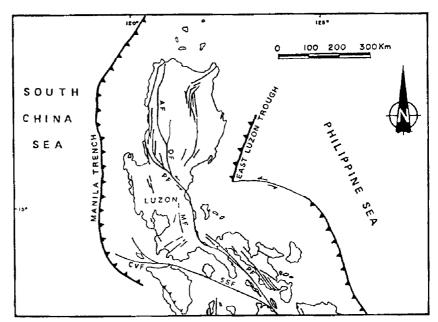
The quake, which was felt over an area of about 500,000 sq. km, was accompanied by a 120-km long ground rupture between Gabaldon and Kayapa along the Philippine and Digdig Faults. A sub-surface rupture is believed to have propagated 50-100 km further North, in Northern Luzon (Sharp, USGS-PHIVOLCS Report, 1991), probably along the Abra River Fault (Fig. 4.8), as suggested by the distribution of aftershocks until February 1991.

Fig. 4.8 - Major tectonic lineaments in Luzon (PF = Philippine Fault, DF = Digdig Fault, AF = Abra Fault, MF = Manila Fault), from Punongbayan and Umbal (1990).

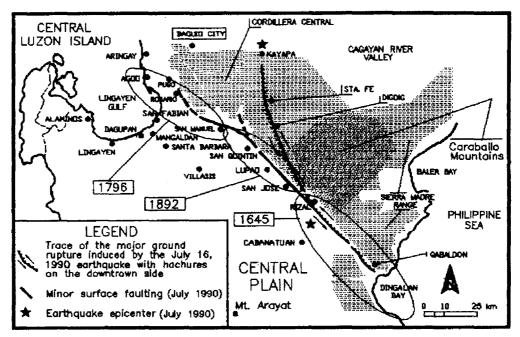
Two minor surface ruptures, shown in Figure 4.9, were also induced by the quake along the north-western portion of the Philippine Fault and splays in the area between Rizal City and Lingayen Gulf. Also shown in the figure are the areas affected by the destructive quakes of 1645, 1796, 1892 in Central Luzon.

The ground rupture started SE of Rizal City and proceeded in jerks, following the zones of weakness of the major lineaments. The strike-slip motion occurred along the Philippine Fault segment connecting Gabaldon to Rizal and along the Digdig Fault between Rizal and Kayapa (Fig. 4.9). The bifurcation point, where the ground rupture splits into a northern and a northwestern segment, is located near Rizal. Horizontal and vertical displacements along the minor surface ruptures West of Digdig Fault (in the localities of San Josè-Lupao-San Quintin and San Manuel-Rosario) were minimal (Fig. 4.1), compared with the slip motion between Gabaldon and Kayapa.

Fig. 4.9 – Location of the Major Ground Rupture and minor surface faultings in Central Luzon associated with the July 1990 earthquake and the areas affected by the 1645, 1796, 1892 earthquakes.

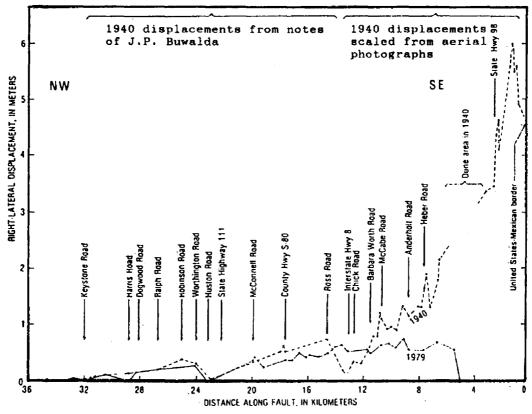
Figure 4.10, by comparison, shows the displacements in California along the San Andreas Fault during the 1979 and 1940 earthquakes. According to Sharp (USGS, Professional Paper 1254) a 5.8 m maximum horizontal displacement, scaled from aerial photographs, was calculated for the 1940 quake in a zone near the Mexican border.

Fig. 4.10 - Right-lateral displacements in California, along the San Andreas Fault, as a consequence of 1940 and 1979 earthquakes (Sharp, USGS Professional Paper 1254).
